Motor Current Signature Analysis

Defective Rotor Bar Problem

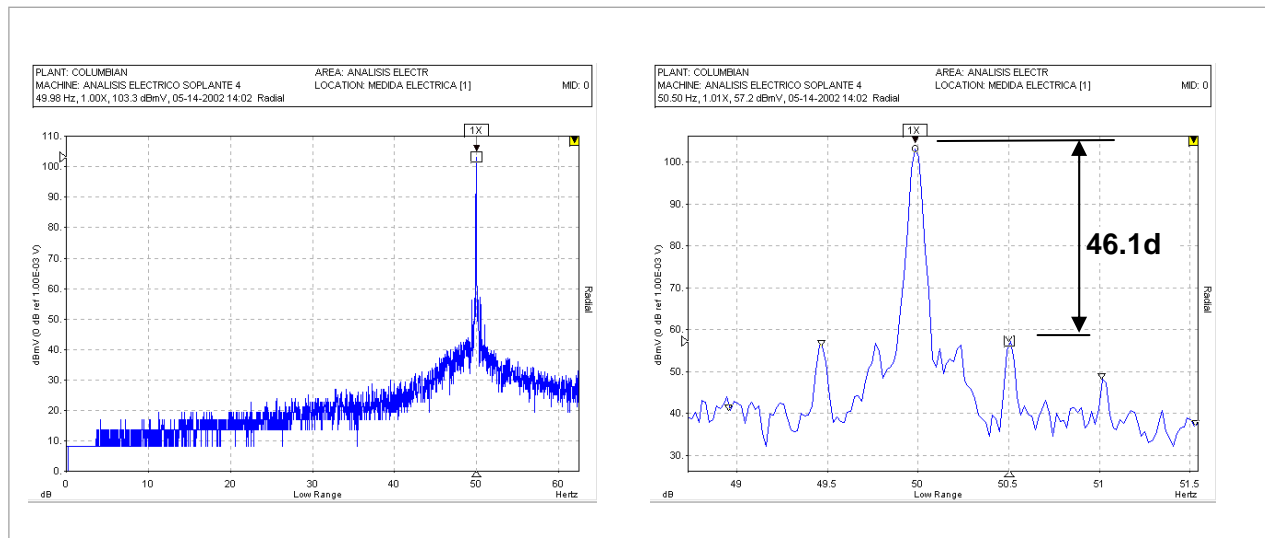
Motor current signature was performed in Europe on a very large two pole induction motor operating at 2985 rpm. See the spectral data below. The 50 Hz line frequency peak is clearly seen in the spectrum on the left. In the zoomed spectrum on the right note the pole pass sidebands (30 rpm spacing) around the line frequency peak.

It is generally accepted that if the sidebands are more than 55 to 60 dB down from the 50 Hz peak, the rotor bars are considered good. If the sidebands rise to within 45 to 50 dB of the 50 Hz peak, damaged rotor bars are likely. When the delta is less than 40 dB, a cracked rotor bar is highly likely. It is important to state that these rules only apply for data taken from a motor that is loaded to at least 75% of its rated load. Additionally these rules apply regardless of whether line frequency is 50 or 60 Hz.
