## Wind Turbine Gearbox Save

### A Failure Report by the Gearbox Manufacturer

**Bearing Type:** SKF 22322E/C3

**Application:** Wind Turbine Gearbox – Serial No. 421.903.143-001-3

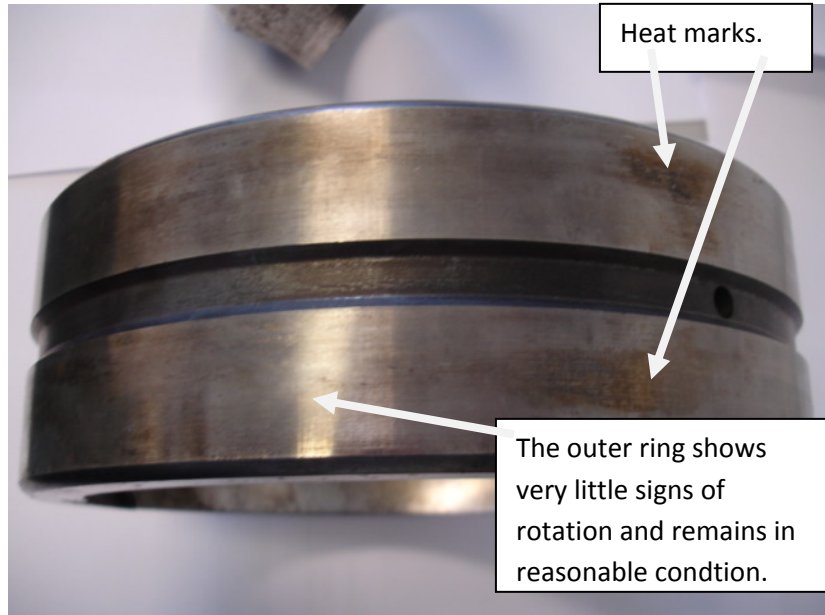
## Outer Ring

The outer ring remains in a reasonable condition, indicating very little signs of rotation within the housing. The heat generated marks could have been caused during removal after collapse of the bearing. No fretting has occurred between the outside diameter of the outer ring and the housing.

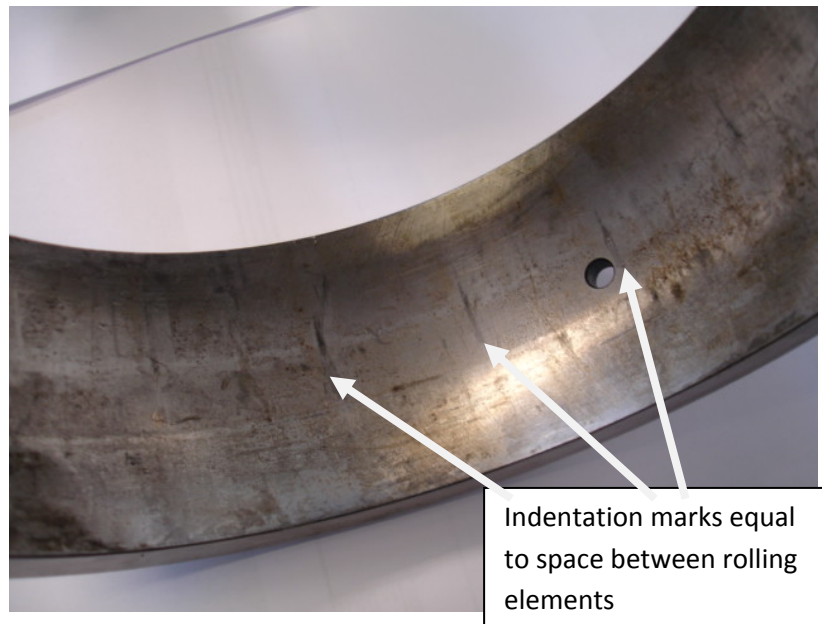
## Outer Ring Raceway

The outer ring raceway shows small indentations and spalling equal to the spacing of the rolling elements. In addition, we see some signs of discoloration from the lubrication.

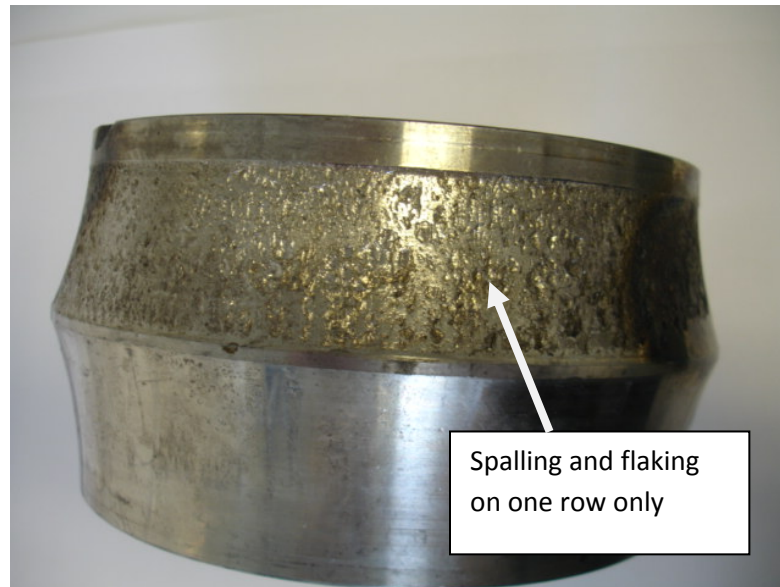
### Inner Ring Raceway

The inner ring raceway has spalling and flaking on one row only. The opposite row has no damage.

The fact that the spalling occurred on only one row further tends to point to the conclusion that the damage has occurred when the bearing has been stationary.

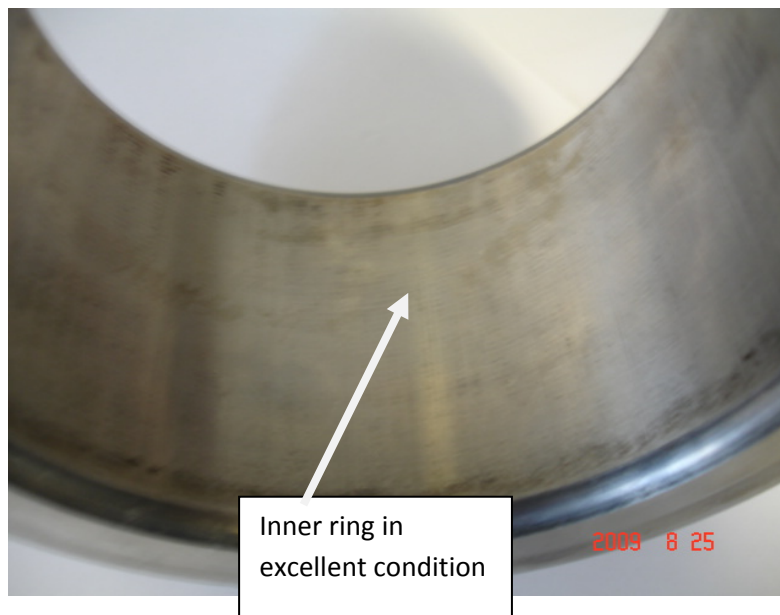
### Inner Ring Bore

The inner ring bore shows no signs of any damage and no fretting has occurred between the shaft and the inner ring.

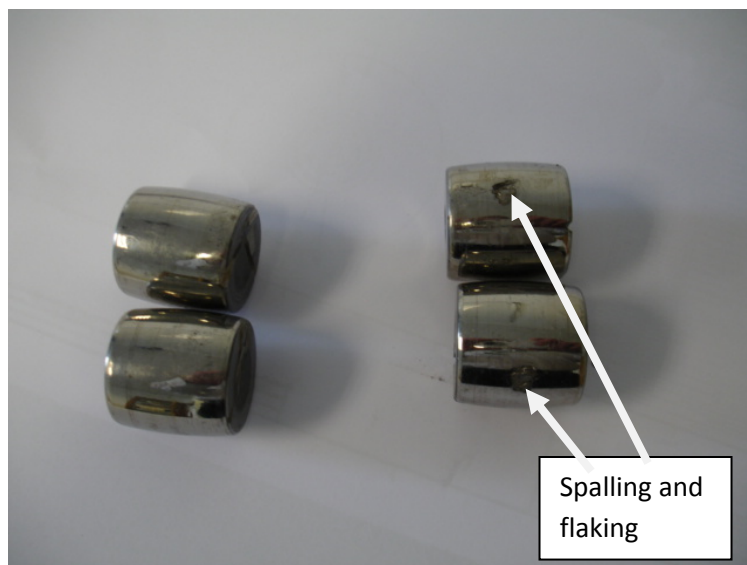
### Rolling Elements

The rollers on one side have flaking and spalling. There is no sign at all of any polishing or any other damage.
