Wind Turbine Gearbox Failure Avoided

Remote Monitoring Service Prevents Gearbox Intermediate Shaft Bearing Failure

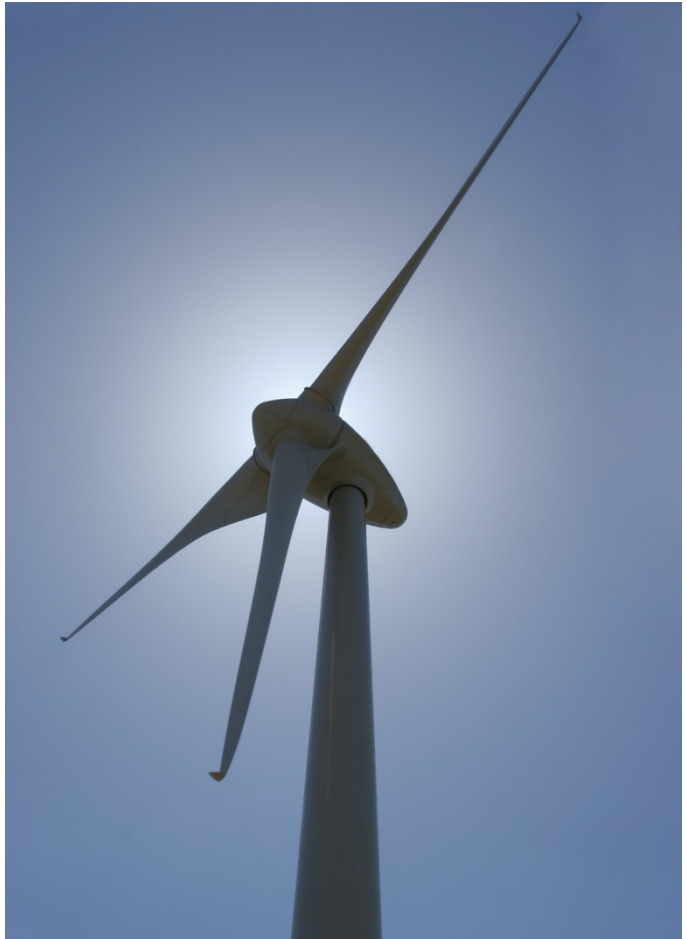
March 6: Steve writes: For the past couple weeks, the bearing tone side bands we see most prominently at locations 2, 4, and 7 of UNIT-2 have been stable. There is often, but not always, the ability to watch the spectra change as a bearing problem worsens. We can watch this turbine, but as you know, a bearing can degrade from serious to failure rather abruptly. I am not sure what other proof they would need; there are prominent side bands spaced at the I2 rotation rate, which is a definite indication of bearing wear.

Fri Mar 13: Bill Watts of Azima DLI writes: I just checked the data and the gearbox condition has clearly worsened considerably over the past few days. There is great deal more higher frequency bearing tones and random noise. I recommend immediate shutdown and repair. Again, the I2 (intermediate) shaft appears to be primarily at fault, although the damage may have become more widespread.
