ExpertALERT™ Automated Diagnostics Performance

201 TON York Air Conditioning Chiller

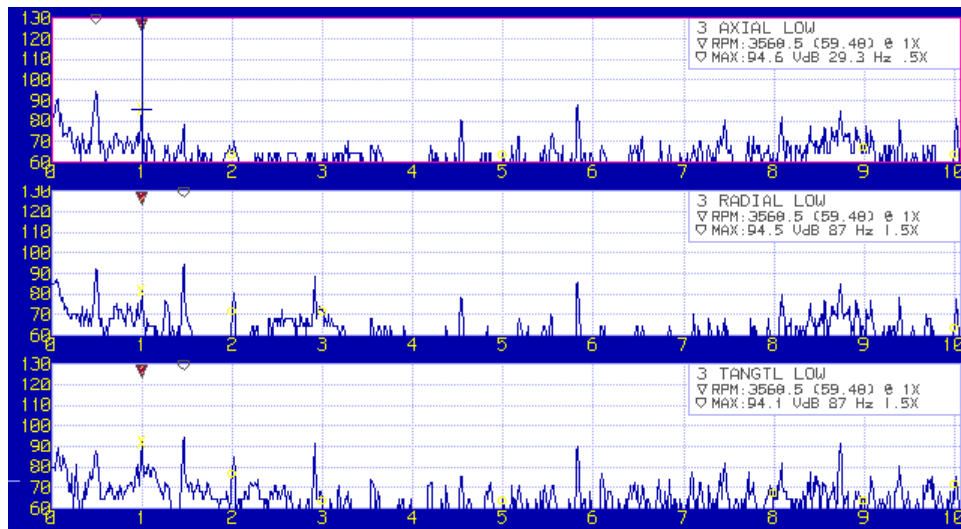
Low Range Data (0-10 Orders)

Journal bearing problems are difficult to diagnose. Unlike rolling-element contact bearings, there is no clear mechanism for generating specific vibration frequencies. As the sleeve bearing wears, the clearances increase. This increase in clearances often times causes a series of harmonics in the spectrum at the running speed. Manual analysis was also performed by an Azima DLI analyst to backup the EADS automated diagnostics, and found to be in agreement with the EADS report (see low and high range graphs below).

SERIOUS COMPRESSOR JOURNAL BEARING WEAR
is indicated by 114 VdB [3A] at 6.00xC

112 VdB	[3R]	at	6.00xC
105 VdB	[3R]	at	8.00xC
107 VdB	[3R]	at	18.00xC
108 VdB	[3R]	at	20.00xC

PRIORITY MED: INSPECT COMPRESSOR BEARINGS FOR PROPER CLEARANCES
Maximum Level is: 114 (+ 7) VdB [3A] at 6.00xC
