# Imbalance in an Induced Draft Fan

## CASE HISTORY

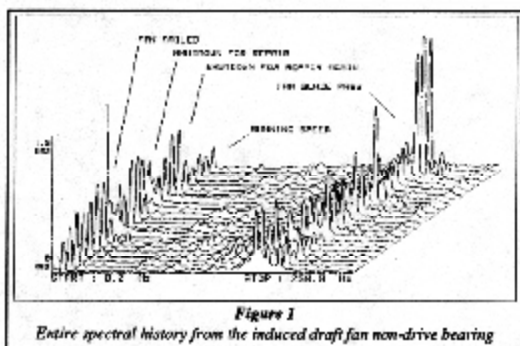
An induced draft fan for a 500 MW steam turbine was being monitored with vibration spectra. It was noted that the running speed peak, at 10 Hz, was increasing. The problem was diagnosed as growing imbalance. Unfortunately, the accelerometer, which is permanently mounted inside the fan, failed under the extreme temperatures (>130 degrees C). Naturally, when this happened, it was difficult to tell exactly what condition the fan was in. Two days later, it failed, and cost the company \$589,400 in lost generation and labor.

The plot in figure 1 is a waterfall plot showing all the spectra that have been collected, 23 in all. The high running peak speed without harmonics is indicative of imbalance.

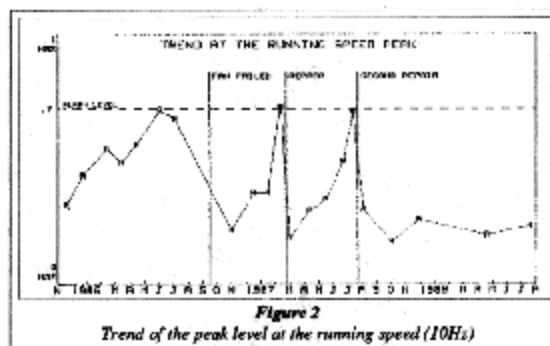
Figure 2 is a trend plot of the running speed peak, that is, it is a graph of the height of each peak in the waterfall plot at 10 Hz, versus time. Using the reporting functions and the history file, it is possible to add notes and completely rearrange the page layout. This format is also useful when attempting to predict when the levels will reach the alarm values.

This function would have been very useful in January and June, in order to predict when the data would reach the level of the previous failure.

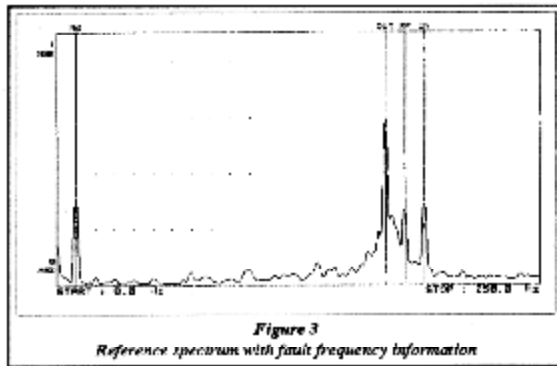
Figure 3 is a simple plot of the reference spectrum, along with the fault frequencies of interest. The first peak is the running speed peak (RS). The peaks at 17, 18 & 19 times running speed are the blade passing frequencies. There are inlet (IN) and outlet (OUT) guide vanes and rotating blades (BP). Given that the pitch of the inlet guide vanes is adjustable, and the angle was not controlled during the tests, the alarm mask, used to automatically detect changes in vibration levels and report on the nature of the problem, would

be designed so that these frequencies would not trip the alarm, because in this case they are meaningless. It should also be noted that an accelerometer was used to collect this vibration data. If a velocity probe was used, the blade pass peaks would appear lower as they are at a higher frequency.
