Wind Turbine Gearbox Failure Avoided

Remote Monitoring Service Prevents Gearbox Intermediate Shaft Bearing Failure

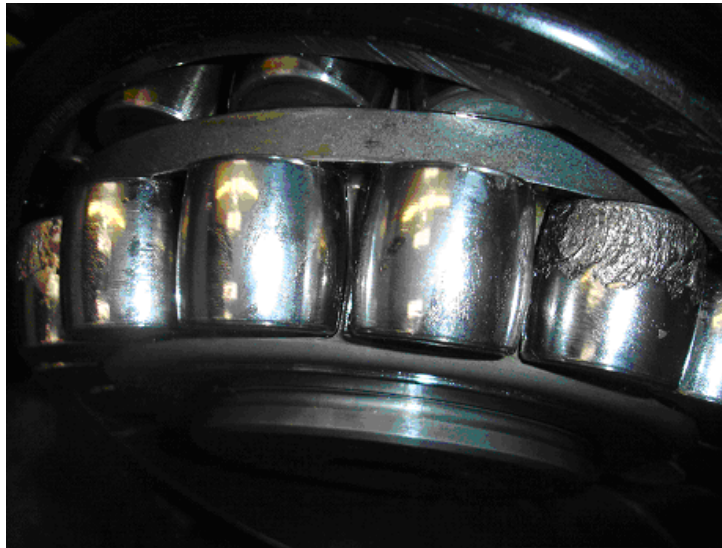
Sat. Mar 21: Dan writes: Gentlemen, Apologies for not getting back to you sooner but I was working on UNIT-2 gearbox Thursday and Friday of this week. The gearbox rebuild company arrived on site Thursday and we found the bearing on the intermediate shaft was severely damaged. It is very similar to what was discovered when the gearbox was rebuilt in July 2008. We were able to replace that bearing and UNIT-2 went back online at 18.00 on the 20th. It will be interesting to see if the gearbox will return to normal levels or if there is further damage in there. The gearbox rebuild company is preparing a report and will send the damaged bearing to its manufacturer for analysis. The gearbox rebuild company also asked me to pass on their appreciation to you for detecting the bearing failure at an early stage.

Monday March 23: Dan writes: Most of the damaged bearing is being sent to the manufacturer for investigation. I do have three of the damaged rollers out of the bearing if these are of any use to you?
