The Damage of Level 7 impeller & lesser Reproducing For the Air Compressor in Company

20000Nm³/h Oxygenerator Line

(Equipment Department of The BenXi Steel &Iron Company, 117021, Benxi, Liaoning)

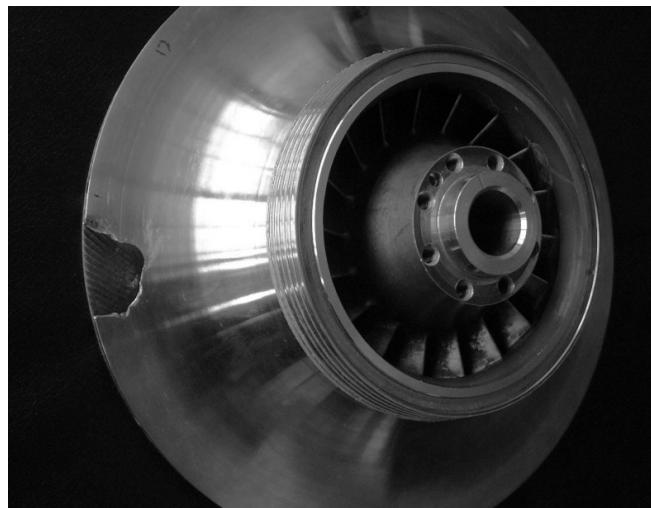
Fig 1 the gap state of impeller

We find the edge of impeller has a gap of 17 \times 25mm through the divided-part examination of the level 7 impeller outlet side. After that, we do the magnaflux inspection and color-up crack detection to impeller with discussion of the engineers of bengang technology center. We find there are 10 cracks at the backside bottom of impeller. The longest crack is 23mm. All cracks produce at the same side edge of impeller. Its character is it appears in the bottom edge of impeller vane. At first it extends towards radial direction forwards, then at the end it begins to turn. The material near the crack has't deform clearly.

The crack character on the front cover is the crack lies in the side root of the vane. It extends forward along radial direction at the beginning ,it starts turn at the end . The material near the crack does't have clear deform. It proves the front cover is brittleness rupture. Judged from the position of crack formed, quantity and outline character,the crack of the front cover is syntony fatigue crack. There is a crack block of 17×25mm at the edge of the hind cover of impeller.

The fracture surface of the hind cover edge of impeller show arc shape.The crack extends forward at the form of being vertical on the surface . The crack source produces on the inside surface at 9mm from the edge. The crack source colour is black. It proves that is metallurgy fracture or manufactured fracture. The crack source include two parts . One is flat, and the other is rough.There is a clear crack extend pause line on the flat fracture area.It proves that is fatigue fracture area. The rough fracture is instantaneous over-load fracture produced by the remain area of impeller vane which can't endure load .The area of fatigue fracture area is larger. The area of the end break is smaller. It proves the work load endured by impeller is smaller. The

The crack block of the hind cover edge of impeller is fatigue fracture. The manufactured defect inside the cover is the main reason produced the fatigue fracture.

Adopting the method of exterior laser welding because of the vane channel narrow and inner welding hard. Namely, open some shallow groove similar to its shape at the damage place of wheel cover and crack place. Filling full the welding material and make it fuse, so will fuse damage part and crack part together. Therefore finishing the welding process.

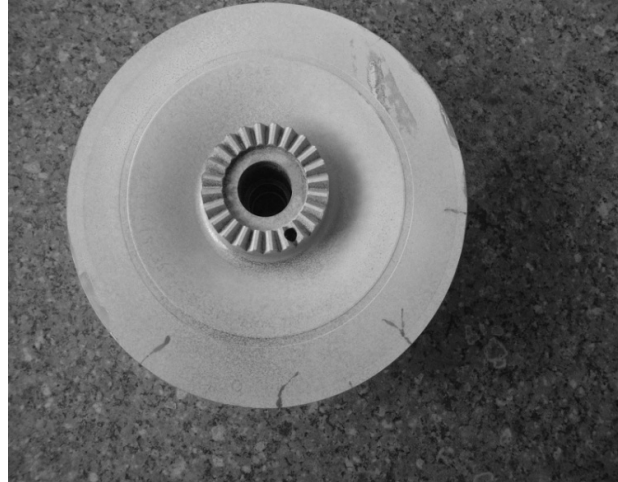
Fig 2 impeller crack show

There are no impact,scratch and corrupt on the front and hind cover of impeller and vane. It proves the damage of impeller is none of the impact and corrupt.There are 10 different size cracks at the edge root of the front cover of impeller found by color- probe inspection ,the longest one is 23mm. All cracks produce at the same side of impeller. There is the grind mark on outside surface of the cover. It doesn't look like during the usage. It maybe be formed during decreasing the weight when commissioning the dynamic balance.

At the same time the edge of the front cover of impeller produce 10 cracks. Judged from this, these crack is syntony fatigue crack. The character of the syntony fatigue crack produce many cracks on the syntony band at one time. If one crack extend leading, the others cracks won't stop extent until fracture. The damage phenomenon of impeller accord with the above rule. The revolution speed of impeller is 31650rpm/min, It has run for one year before damage. Proved from this, the crack produced is none of impeller design. It is caused by over-limit oscillate value.

The crack on the front cover edge of level 7 impeller of Centrifugal compressor is syntony fatigue crack. The strong vibration is the main reason of producing syntony fatigue crack when running. The oscillate source of the compressor is caused by the airflow disturbance inside the compressoe body. Its main reason is the design cause of the radial seal. Later manufacturers adopt our suggestion, they will change the 32 radial seal, the channel which prevent airflow disturbance into 27, so it eliminate the oscillate source completely. The crack block of the hind cover edge of impeller is fatigue fracture. The metallurgy or manufacture defect existed in material is the main reason of producing fatigue fracture.

- 3.1.1 Make step shaft, measuring the jump dimension of two vane of impeller and the each position dimension of all body.
- 3.1.2 Clear crack, eliminate slope and clear crack block place.
- 3.1.3 Intensity calculate and life-span evaluation; invalidation reason analysis;
- 3.1.4 Laser melt 10 cracks and break block.
- 3.1.5 Trim skin pass, recover original dimension, polishing;
- 3.1.6 Probe detect inside defect;
- 3.1.7 Finishing grind inspection, measuring skipping value;
- 3.1.8 Vacuum temper treatment;
- 3.1.9 X-ray detect;
- 3.1.10 The balance test to the repaired level 7 impeller;
- 3.1.11 Detect frequency to the repaired level 7 impeller;
