Using Infrared Thermography with Ultrasound to predict mechanical failures

**William Mitchell
Thomas Griswold
United Parcel Service
Hodgkins, IL**

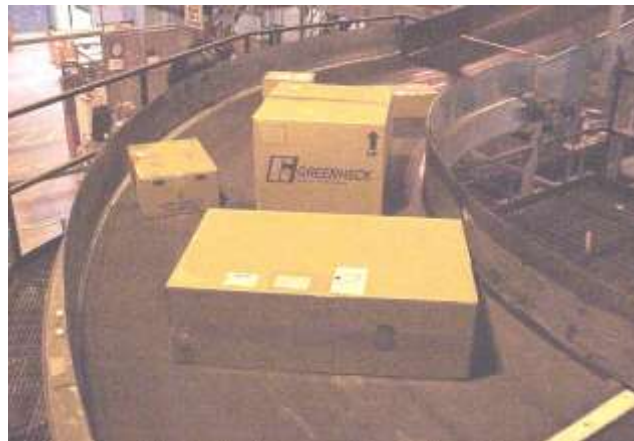
One instance where we have integrated predictive technologies is on our "power curve" conveyors (**Figure 1**). All of our package sorting lines incorporate one or more of the Transnorm 1500 series belt curve conveyors. These power curves consist of various shapes and sizes. Currently there are 452 power curves installed at CACH, most in critical sorting areas. Failure of the conveyor in any way could result in several hours of downtime leading to loss of production and increased maintenance costs. Prior to utilizing predictive maintenance technologies there was not an effective method of diagnosing power curve problems while they were operating.

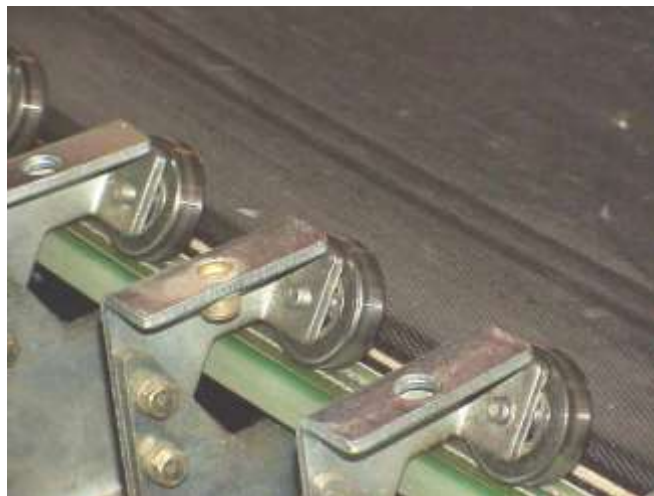
Figure 2

To fully explain what problems we encounter, one must understand the nature of a power curve conveyor. The conveyor belt is driven by an AC motor that is connected to the pulley by a sheave and polychain. These conveyors have a conical belt that is folded flat and tightened around 2 tapered end pulleys. As rotation starts, the conical belt tracks inward. Transverse forces occur and have to be diverted. The belt is provided with a highly elastic edging strip (bead), flanged top and bottom (**Figure 2**) with a durometer of 75. The flanges of the edging strip are centered between two rows of ball bearing guide rollers set at an angle. One row is on top and one row is on bottom for the return. The guide rollers prevent the belt from tracking off line.

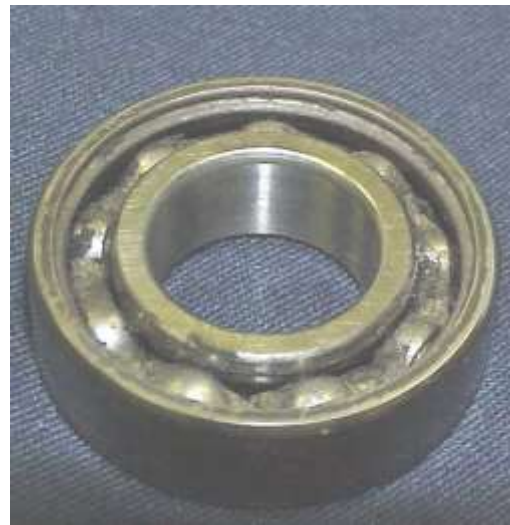
Figure 9

The old guide rollers were saved for evaluation. Upon inspection of the guide rollers, excessive amounts of dust, grit and a lack of lubricant were observed (**Figure 9**). This analysis was accomplished by removing the bearing seal to expose the inner housing.

After reviewing our findings with our guide roller supplier, we switched to a guide roller with a tighter seal fit. The new guide roller has zero clearance between the seal and the inner race where the old one had a .003" clearance.
