Rubber Plant Avoids \$400K in Lost Production

Vibration analysis catches loose base plate before catastrophic BFW pump failure.

Site: Synthetic Rubber Manufacturing Plant in southern U.S.
Area: --
Asset: Boiler Feed Water Pump
Date: June 2010
Analyst: Keith Matherne
kmatherne@azimadli.com
225-368-7520

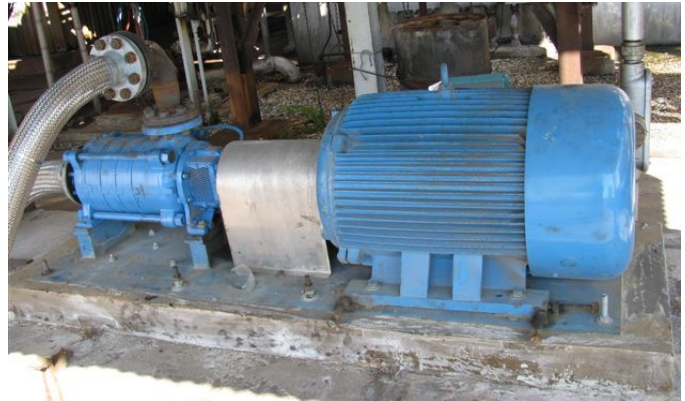
The Azima DLI analyst noted that vibration was too high immediately after collecting the first data set.

Suspecting a loose base plate, the analyst performed cross-phase analysis to confirm his diagnosis and also to pinpoint where stiffening was needed.

To re-confirm the diagnosis, the analyst stabilized the base plate by inserting brass wedges in strategic locations around the plate. Another set of data demonstrated that the temporary stabilization technique had been effective in reducing vibration levels.

Since taking the pump out of service for repairs was not an option, the analyst suggested the brass shims remain in place and recommended the operating speed be reduced slightly to further help dampen the vibration. The plant's staff was urged to take regular vibration readings until the next scheduled outage in case the situation deteriorated. The analyst also recommended studs be installed in various locations on the base plate until permanent repairs could be made.

For the long term, the analyst recommended the base plate be permanently stabilized by adding grout under it at the next available outage.

The plant's maintenance team followed all of the analyst's recommendations and the pump ran without further incident until the outage. The permanent repair was made at the outage and the pump has been running smoothly ever since.
