Trio Analyzers – The Inside Story

Ken Piety
VP Technology
October 2013

The Trio – A Two Component Analyzer Design

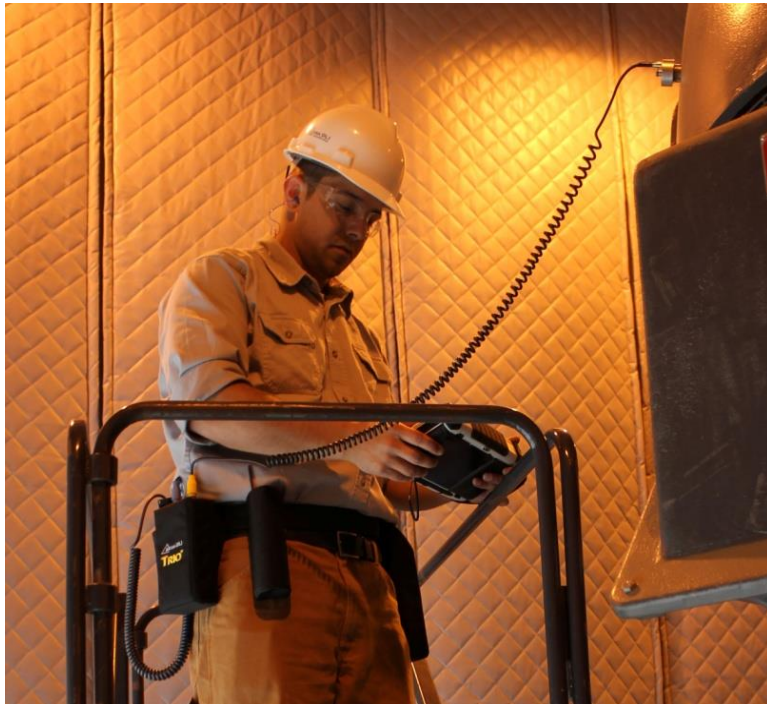
Two Component Design Advantages

- **Basic packaging has been the same since 1985**
 - Single-unit, monolithic design
- **Two-component design with wireless capabilities delivers benefits over current packaging**

Better suited for humans with one or two arms

Better distribution of weight and lighter handheld controller

Greater safety when cables do not dangle in front of you

Signal processing unit is self-contained, protected, and rugged

Easily interfaced with a host of low-cost controller options (new instrument lifecycle strategy)

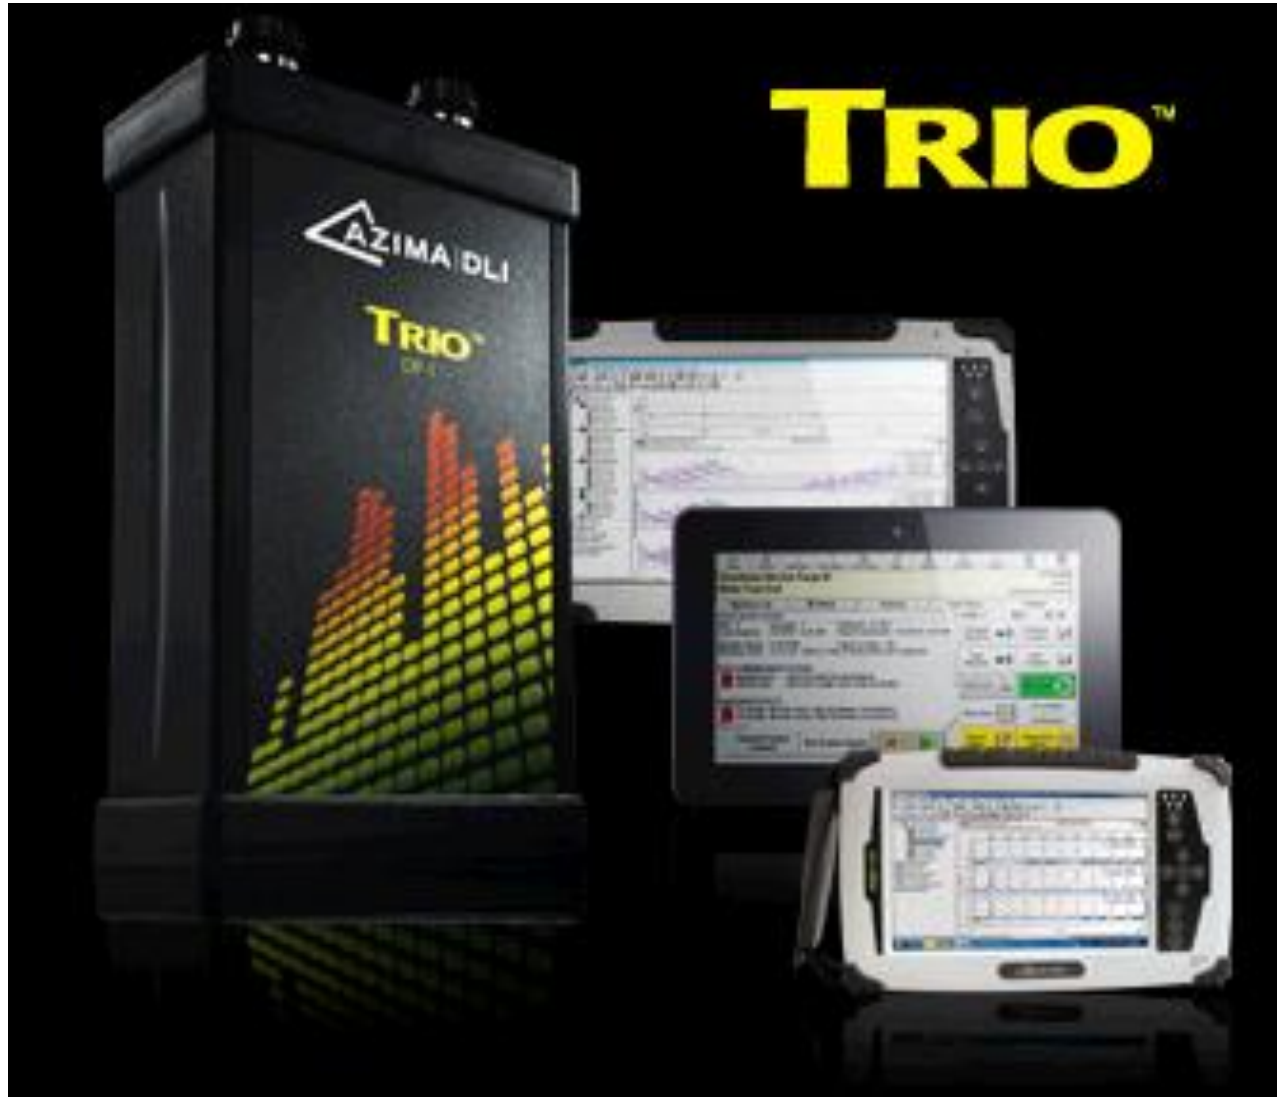
The Trio – Controllers options will change/improve over time but the data processing unit will not need to change to provide high quality data on request...

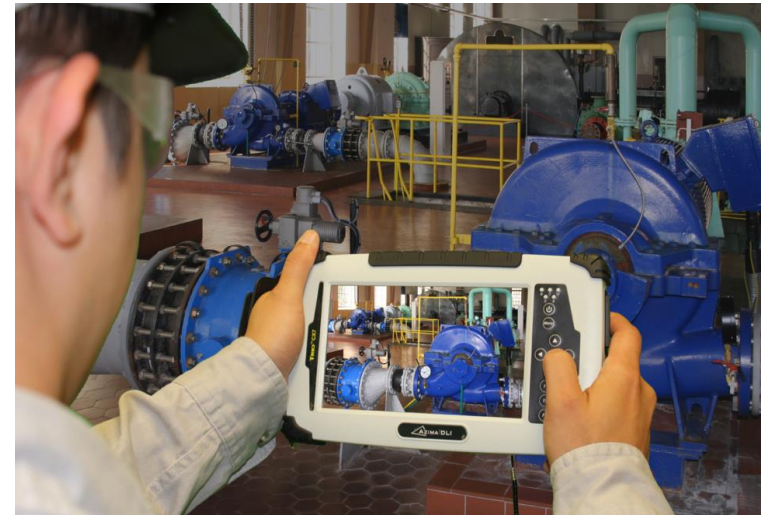
What We Accomplished with the Trio

Very flexible and expandable product design

Replaces and improves DAQ functionality

Higher frequency range (40kHz)

Four signal processing channels

Dedicated tachometer with integral control

Improved dynamic range (24-bit A/D)

Enhanced measurement modes
(impact demod, order tracked sampling,
new trigger modes, and more to come)

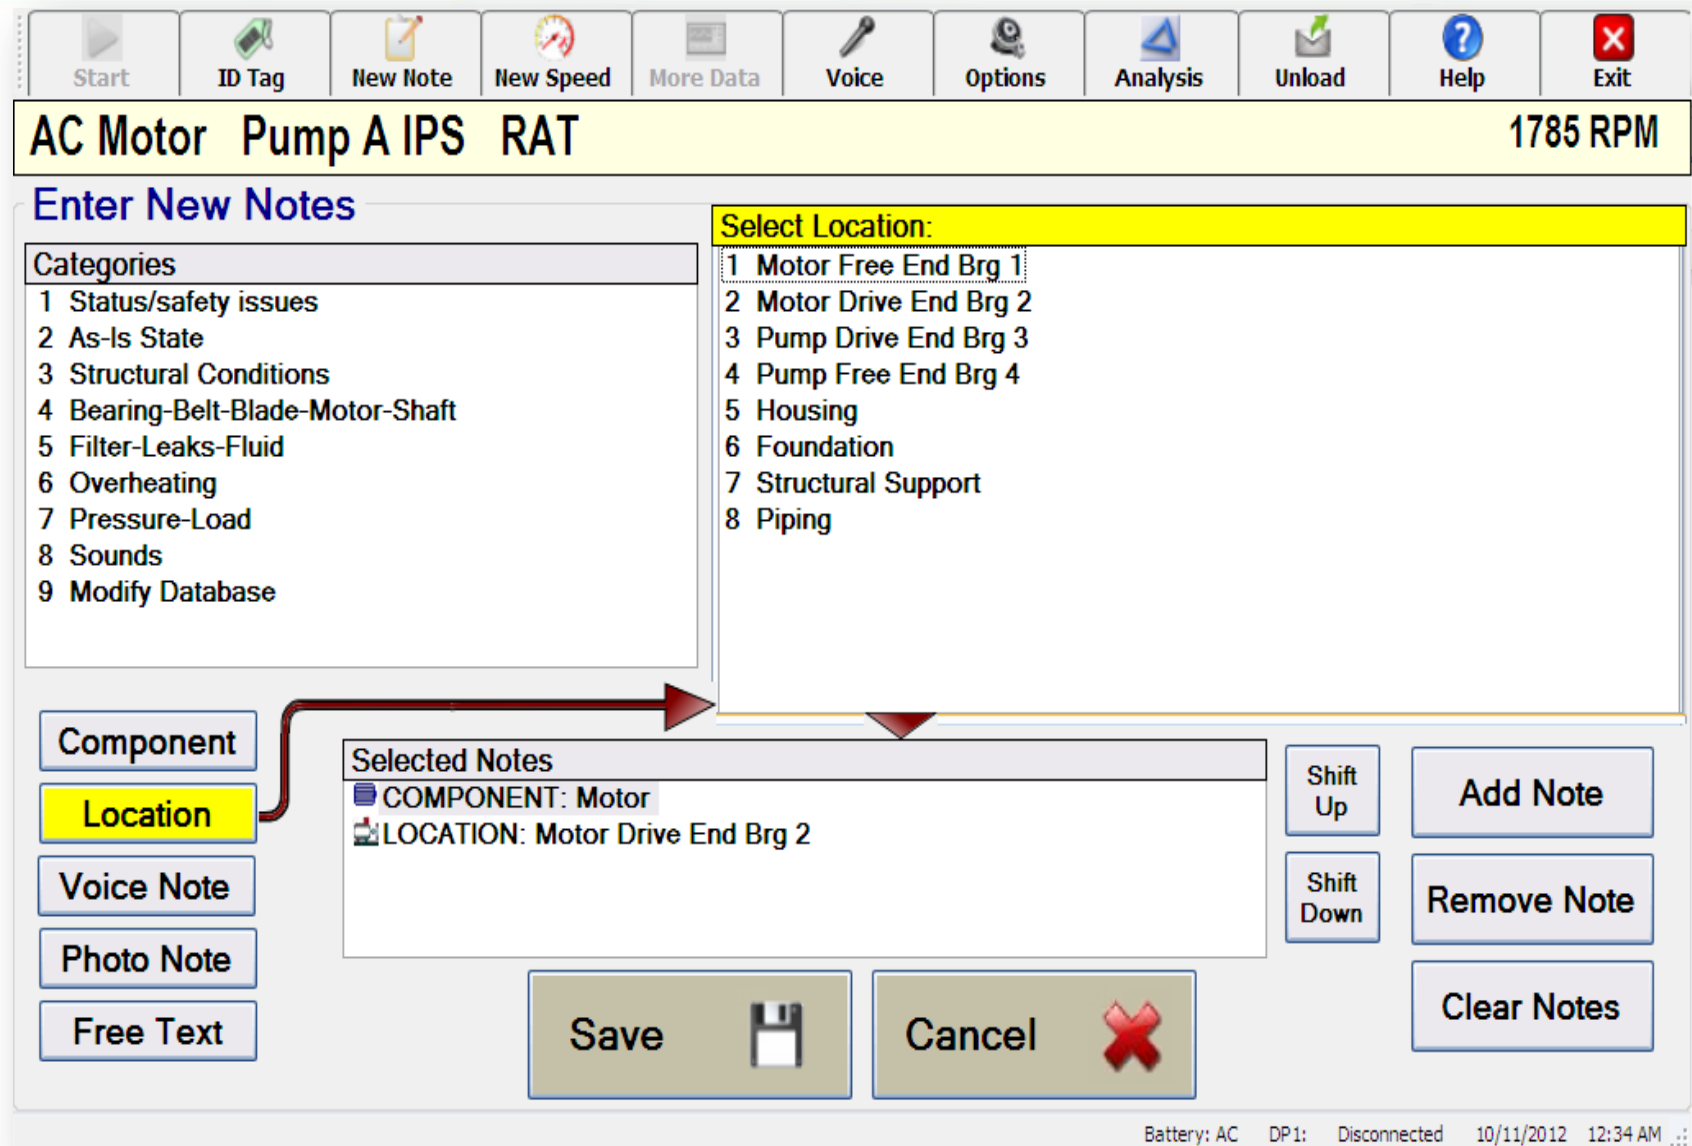
Define the Component and Location

The screenshot shows a handheld device interface with a top toolbar containing icons for Start, ID Tag, New Note, New Speed, More Data, Voice, Options, Analysis, Unload, Help, and Exit. Below the toolbar, the header displays "AC Motor Pump A IPS RAT" and "1785 RPM".

The main area is titled "Enter New Notes" and is divided into two sections:

- Categories:** A list of note categories: 1 Status/safety issues, 2 As-Is State, 3 Structural Conditions, 4 Bearing-Belt-Blade-Motor-Shaft, 5 Filter-Leaks-Fluid, 6 Overheating, 7 Pressure-Load, 8 Sounds, 9 Modify Database.
- Select Location:** A list of location options: 1 Motor Free End Brg 1, 2 Motor Drive End Brg 2, 3 Pump Drive End Brg 3, 4 Pump Free End Brg 4, 5 Housing, 6 Foundation, 7 Structural Support, 8 Piping.

Below these sections is a "Selected Notes" area containing:

- COMPONENT: Motor
- LOCATION: Motor Drive End Brg 2

On the left side, there are buttons for "Component", "Location" (highlighted in yellow), "Voice Note", "Photo Note", and "Free Text". A red arrow points from the "Location" button to the "Selected Notes" area.

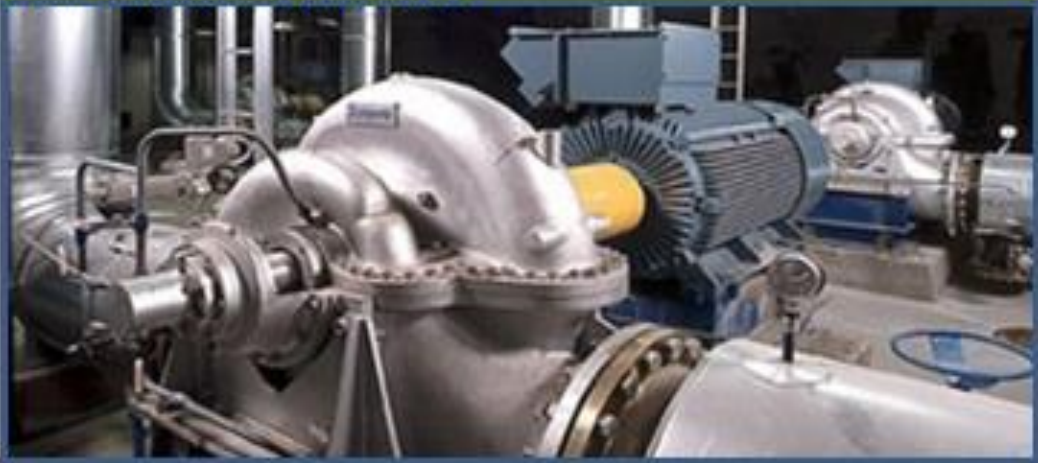
Picture Field Notes

Press "Snapshot" to Take Photo

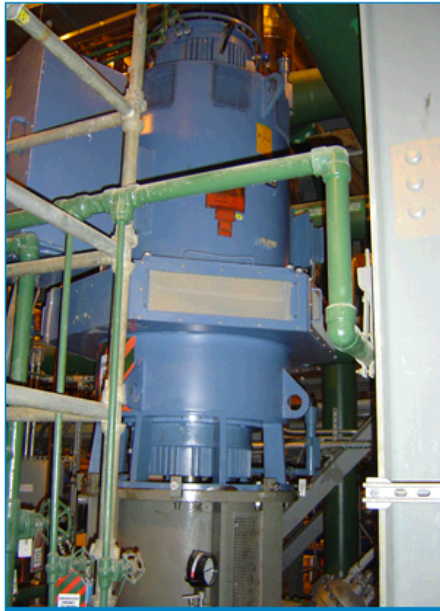
Recommended Actions
IMPORTANT: INSPECT SYSTEM FOR FLOW ISSUES / INSPECT IMPELLER FOR DAMAGE

Identified Problems
SERIOUS PUMP CAVITATION OR AIR INGESTION

Analyst Comments
DIAGNOSIS:
Elevated levels of cavitation are noted by the obvious raised noise floor in the high-range spectral data. When viewed in Acceleration format, the levels are reaching 0.3 G's. Additionally, waveform data reveals random impacting at moderate levels, indicated by pump cavitation noise as opposed to bearing defects or other mechanical events.
RECOMMENDATION:
Unit should first receive inspection for any obvious flow issues; i.e. flow restrictions, improperly operating valves / controllers, uneven system pressure, etc. Assuming no flow issues are present, then physical impeller inspection should be done to check for any issues leading to the cavitation issues currently being experienced.
