REPAIRING AMPLITUDE CYLINDER OF THE PILE FRAME IN AN ENGINEERING SHIP

—A COMPOSITIVE REPAIRING TECHUIQUE BEING USED

Xie Daoping¹ Cheng Zhongmen²

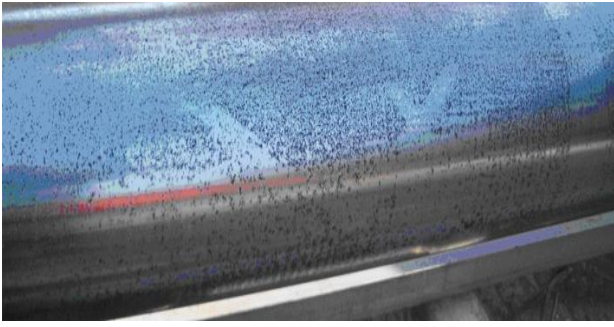
The result of test indicates that: the wear loss of the piston rod has increased, and the length of the original chrome surface layer extended from 3m to 4.6 m and depth of 1mm by the corrosion (Figure 1); the wear loss of the inside of the cylinder casing turns to worn surface with width of 300-500 mm, length of 5.1 m and depth of 1mm from the original three broached groove (Figure 2); the upper end cover worn badly, and v-type seal ring was in disguised form also (Figure 3).

(Figure 1)The wear loss of the piston rod

4.1. Adopt the multiple technique including cold remelting and directional metal ions deposition to repair the piston rod.

The entire process of repair is: repairing the surface----- cleaning-polishing the surface----- cold remelting of the eroded and worn surface (the technique of sloppy heat with resistance at normal temperature) ----- directional metal ions deposition of the eroded and worn surface(the technique of special brush plating)-----reinstatement the worn surface to the dimension-----the treatment of mechanical polishing . After the process ,the repair requirements should achieve the demand for the corrosion resistance, wear

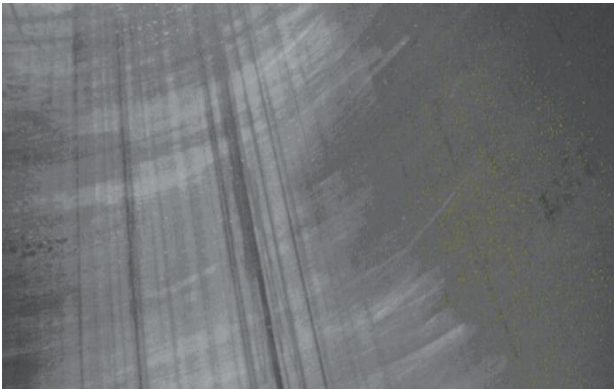
(Figure 2)The wear loss of the inside of the cylinder casing

4.2 Restore the hydraulic cylinder liner with composite technics of cold remelting and macromolecule nano-materials.

Process: Repairing the surface of radical body → burnishing surface → clearing and laundering → cold remelting the pulled and worn surface → restoring the macromolecule nano-materials of the pulled and worn surface → polishing disposal with mechanical rubbing → the pulled surface resume to

There are three worn groove in the hydraulic cylinder liner (near the bottom position in the oil tank knot), the specific dimensions are as follows: The first one is length 3.2 m × width 0.5 m × depth 1 mm; The second one is length 5.1 m × width 0.3 m × depth 1 mm; The third one is length 5.1 m × width 0.38 m × depth 1 mm. Repair of the technics operational flow is the same as repairing the piston rod. Because the worn deepest recesses achieve 0.2 mm, in the repair, we adopt the macromolecule nano-materials to deal with it. If there is dozens of injury, we adopt the composite technology of cold remelting and metal ions' directional deposition (brush).

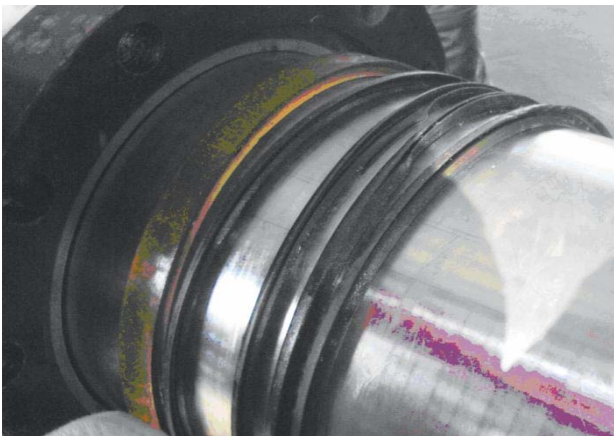
(Figure 3)The wear loss of the upper end cover

After removing the dustproof circle of the upper end cover, we found the guiding ring in the oil seal of end-cover combination had been seriously contorted, and the material is copper ring, the seal ring of V type combination had changed. For the replacement of this guiding ring, we substituted SL-012 enhanced modified nylon 610 material for processing guiding ring of copper, SL-012 takes nylon 610 as its basic material and is modified by the modifier, the nylon modified materials with glass fiber enhanced, have the advantages such as high intensity, the bottom temperature (-40°) isn't sensitive to notched impact, good stability of size, oil resistance, solvent resistance, good wear resistance, self-lubricating, and so on. The materials are cheap and easy processing.

The repair need to resolve the problem of leaking oil tank, because the hinge head of oil tank doesn't taken down, the oil seal at the position of replacing oil tank' upper end cover need deal with incision. The airproof structure of upper end cover is shown in Figure 10;

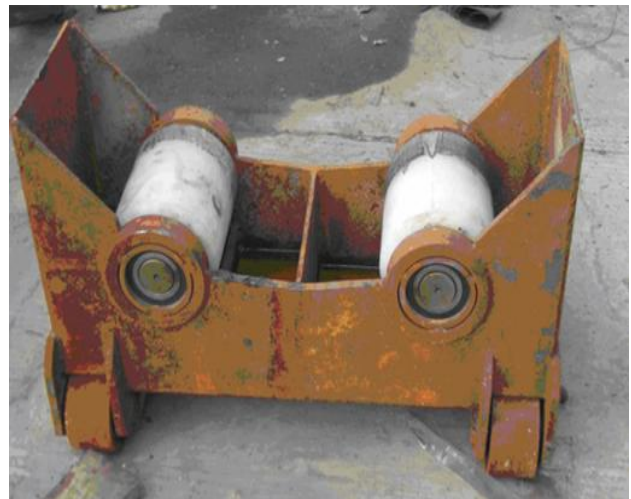
(Figure 4)Put 2 walking cars on the channel steel

The repair of piston rod in the workshop, using sleeper by laying down according to the space of 3meter, and putting 2 root of channel steel with the length of 8 meter on the sleeper(channel steels are convenient for car to slide). Put 2 walking cars on the channel steel (Figure 4), then suspend the piston rod which is about to be repaired to the walking cars (the space of the car is not less than 5 meter). Since the piston is non-disintegration, pay attention to protecting oil seal on the piston. Determined the position to be repaired, by the actual measurement, the length of abscission layer is 4.6 meter which is from the projected head of piston rod. It's has been more than three years since the last completely knocked down repairing, and the corrosive situation is serious enough.If the hydrocylinder can not to be repaired soon, it would not work properly. Using the outside micrometer to measure the size of the datum plane after you have clear the hydraulic oil and the oil stain outside by the cleaning agent(Measuring the surface that doesn't weared which is leaned on the bottom of the piston).To repair it by using the size of this surface as the datum plane.

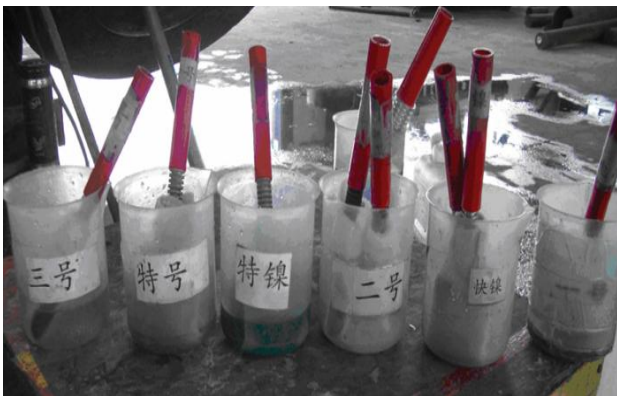
(Figure 5)Activation Solution

Using the Contravariant pulse electrobrush plating for brush plating, the sequence follows: electrocleaning—use the first activator for activation—use the second activator for activation—use the third activator for activation—use the forth activator for activation—use the fifth activator for activation—use the super-standard activator for activation—Chromium-activation—special nickel—nickel-chromium alloy.It’s better to choose the activation of copper for the surface that has more corrosion and to repair the pocking mark. Activation Solution(Figure 5).

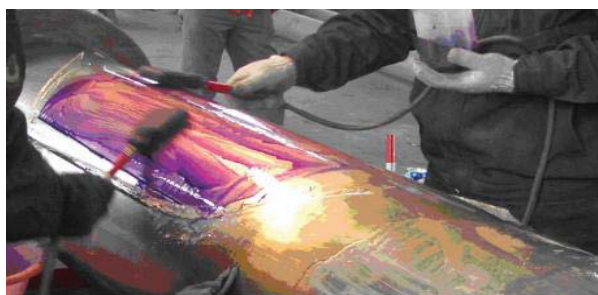
(Figure 6)In the process of brush plating,the quality is determined by the control of temperature ,current and the touch of the operator.

In the process of brush plating,the quality is determined by the control of temperature ,current and the touch of the operator.(Figure 6). Especially for the transition of the repair which is the nodus of the repairing. That is whether the two materials can be hook up properly or the control of transition’s size effectively. In order to solve this problem the repair spent more than 10 days time,for the first thing is to ensure that the size is to meet the requirements and the second is to

ensure that there is no traces of repair. For another difficulty is that whether the repair materials can combine with the body suitably,which means crack-free and non-points.In the process of repair, adopted a waffle slab technics to change internal stress to ensure the crack-free and no point after the repair.

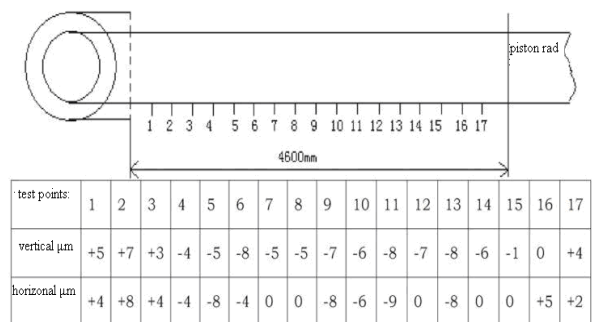
(Figure 7)The test result using the micrometer

Test results show that: The glossiness of surface meet the requirement after being restored (see picture 18). It meets the requirement that the deviation is controlled within $\pm 10 \mu m$, testing the hardness with the hardness tester, the hardness achieve above HRC55.

Detection it after repairing, no traces of repair, crack-free,be have no point,and no anesthesia,as well as no the phenomenon of delamination. The test results with the outside micrometer is as follows(Figure 7):

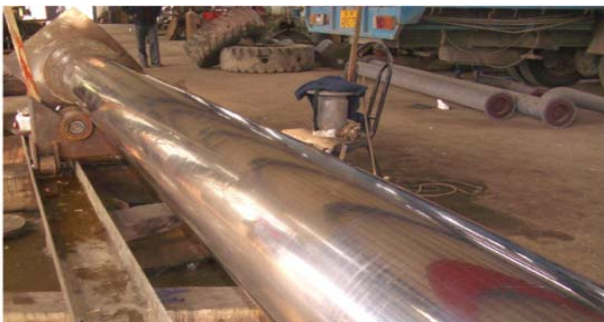
(Figure 8)The effect picture of restored hydraulic cylinder piston rod

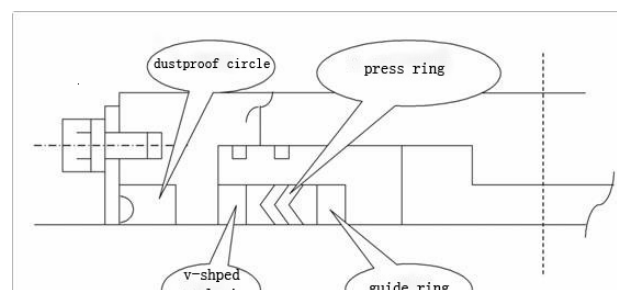
(Figure 10)The airproof structure of upper end cover

Installing seals at the end-cap is as follows: First, process a guide ring with SL-012 enhanced modified nylon 610 material, and cut two bevel installation. Second, install seals of V-shaped, and cut a incision on each of the four V-shaped rings, the direction of incision displaces 180° and it's installed successfully. Third, install the press ring, the incision of which staggers with V-shaped ring. Fourth, install the gland. Fifth, install the dust ring (bond with viscose after cutting). Sixth, install the platen of dust ring.

While installing seals at the end-cap, pay attention that the height of combining seal is 53mm, which can be adjusted and controlled by the height of processing guide ring.
