CURE OF STEEL GIANT

Abstract : This article tells us the technology way of the ten thousands tons water press plunger piston damaged surface cementation repair

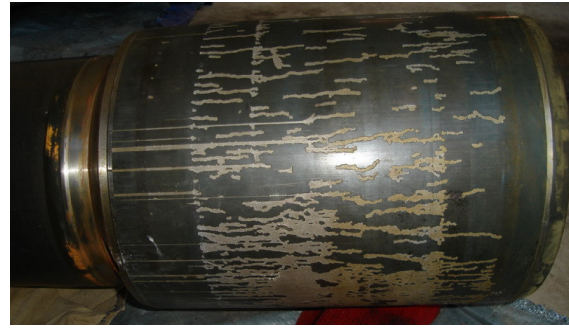
During the forging ,when the cross beam going down , the main cylinder in right side delayed , bader and bader in future ,at last the steel giant didn't work .after being disassembled to check ,the main valve rod's hoisting piston surface coating of the prefill valve on the top of the main cylinder was damaged all over .The prefill valve of the ten thousand tons water press is imported from one of the foreign famous company ,the excircle of the hoisting piston of the water press main valve rod is \varnothing 260mm , the length is 800mm ,the sliding surface is used from a special procedure and patent technology ,the thickness of the coating is only 0.15mm.

Before repair

surface treatment: we research the peeled off surface coating of the original part, the main reason is the bad surface treatment. so we machine its surface by lathe, look at the attached sketch, the depth of

the groove is about 1mm and make the coating thicker.

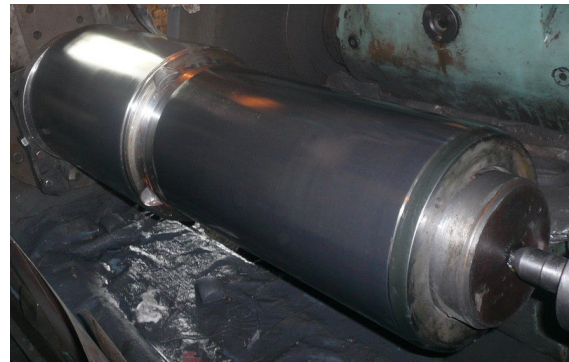
After repair

the roughness of the piston surface 0.2um, the

roundness is 0.015mm , concentricity is 0.015mm ,
the import parts .

the dimension tolerance is 0.03 mm , it is better than

mixture : according to the production instruction of the AK02-3, the mixture should be done as soon as possible in order to have enough time to coat.

coating : to clamped a wiper on the cutting tool holder, the cutting tool holder moves along the longitudinal direction to coat the mixture along the axial direction on the adhesive area of the work piece excircle needed surface equally.

solidification : in order to improve the mechanical properties and the hardness, heat the coating in a hour. run the work piece held in the lathe at low speed to make the heat of the work piece equal, the heat temperature is about 50°C.

machining : after the solidification of the coating and the adjusting, rough machining, finish machining, finish grinding, finish polish.
