The Damage of Level 7 impeller & lesser Reproducing For the Air Compressor in Company

20000Nm³/h Oxygenerator Line

(Equipment Department of The BenXi Steel &Iron Company, 117021, Benxi, Liaoning)

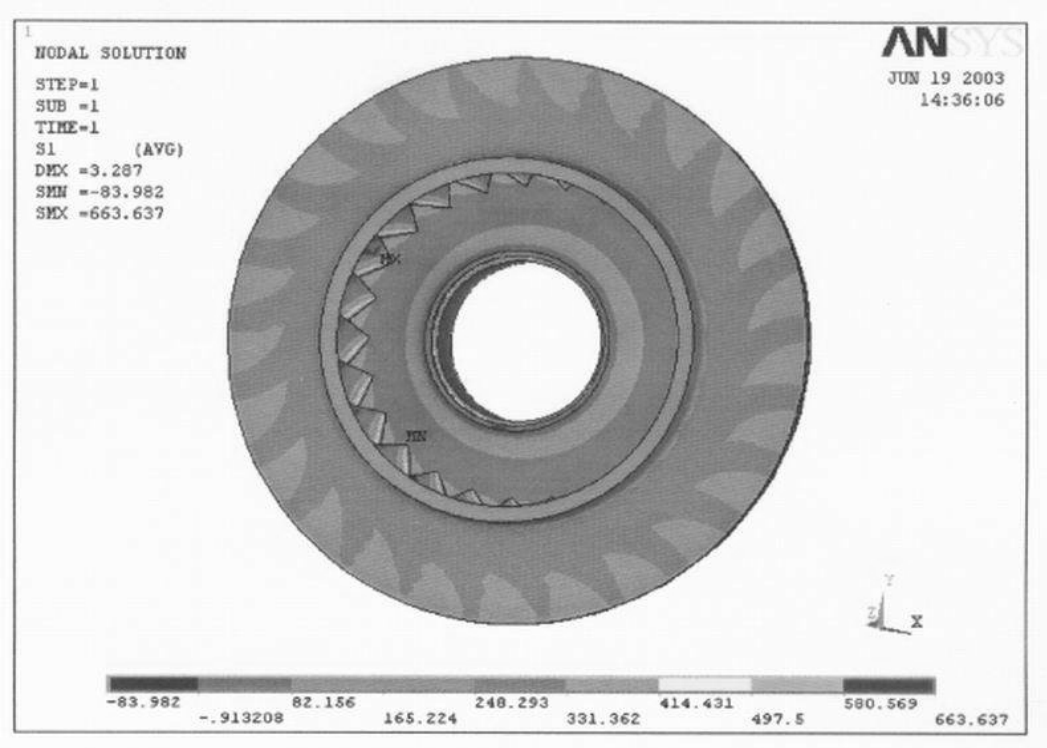
Fig 3 computer strength calculation model

The stress value is proportional to the square of speed ratio. The maximum stress appear in over-speed experiment (the speed is the 115% of the largest continuous revolution). Especially should pay attention to the stress area of vane work root part. When designing and machine the each surface of impeller. And as a principal, should especially avoid the concentration of stress and especially consider thickness, key channel and rounding in the process of the manufacture of impeller. When choosing material and heat treatment, should consider the stress caused by eccentricity and the impeller work surrounding.
