Ultrasonic Detectors in Space

By George Studor, Johnson Space Center/Structural Engineering Division
May 22, 2002

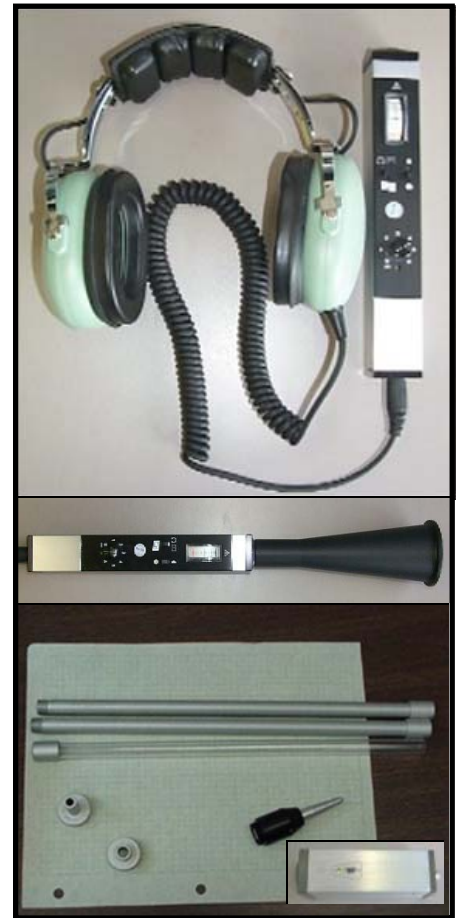
Above: ULD and components

The Ultrasonic Leak Detector (ULD) kit, made by CTRL Systems, Inc. (www.ctrlsys.com), has a simple battery-powered ultrasonic (40KHz) receiver that provides a corresponding audible representation of the level of Ultrasonic noise into a high quality headset. Various attachments allow the microphone to have varying degrees of focus. There is an attachment that also allows the user to detect ultrasound transmitted through structure such as sensing fluid flow-by of an internally leaking valve in a pipe. A transmitter is available to flood a cavity that is supposed to be sealed, to determine if any leaks are present without pressurizing the cavity with air or fluid. Other attachments to the ULD allow the device to discern the condition of bearings, gears, seals, and valves, as well as identify corona discharge to ground and electrical discharge -- making the ULD a valuable tool in
